APPENDIX A: MURPHEY CANDLER STATE OF THE LAKE REPORT 2015

Murphey Candler Lake

State of the Lake Report

APPENDIX B: PROJECT SHEETS

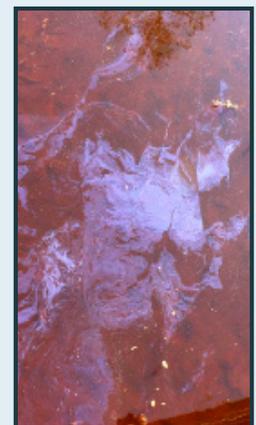
The shiny, orange-tinted substance is iron bacteria. It is a natural byproduct and is not harmful. It is found more frequently in still water.

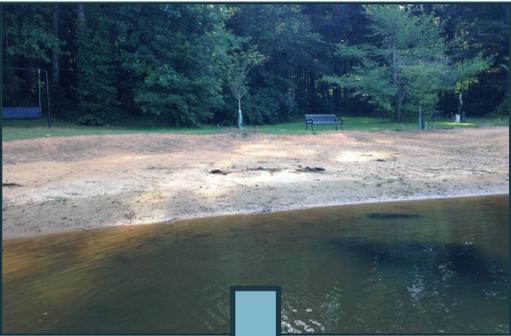
Current Shoreline Area, "the Beach"

Shoreline Restoration Example

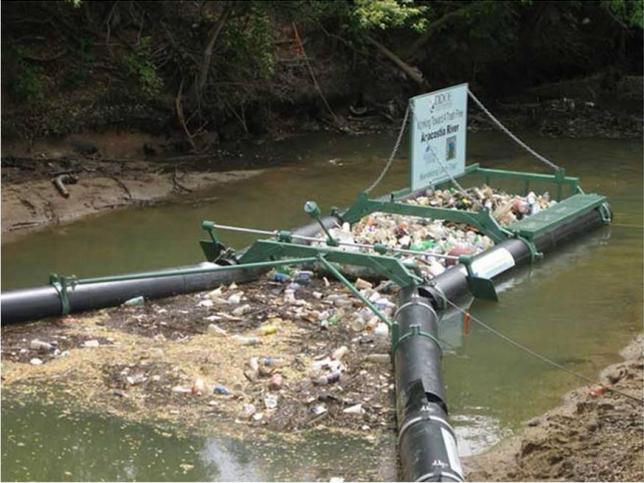
IMPLEMENTATION INFORMATION		EXAMPLE OF RECOMMENDED PROJECT
Planning Level Planning/Design/Permitting Cost (\$): 12,500

Project ID#: NC4-001	
Sub-watershed: NC4 North Fork Nancy	
Practice Type: Trash Rack	
<p>Description: Trash rack to capture debris/trash from I-285 runoff. Recommend a floating trash rack downstream of the culvert to capture floatables and debris from the catch basins and associated drainage channels.</p>	
<p>Watershed Goal(s) Supported:</p> <ol style="list-style-type: none"> 1. Meet state water quality standards: Yes 2. Restore stream buffers: No 3. Improve streams to sub-optimal condition: No 4. Wildlife diversity and aesthetics: Yes 	
GENERAL SITE INFORMATION	SITE PHOTOS
Owner: GDOT	
<p>Existing Conditions: Trash and debris from I-285 flow downstream into Murphey Candler Lake.</p>	
WATER QUALITY MODELING DATA	
Contributing Drainage Area (ac): 10	
Contributing Impervious Area (ac): 10	
Primary Hydrologic Soil Group (HSG) in DA: NA	
Annual Total Nitrogen Reduction (lb/yr): 11.77	
Annual Total Phosphorus Reduction (lb/yr): 1.28

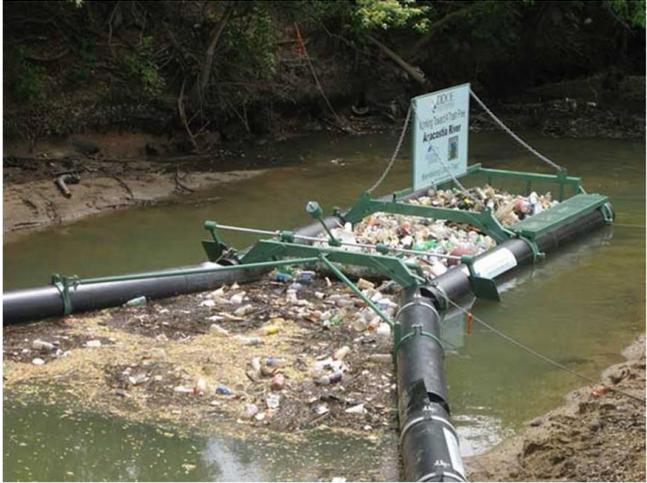
IMPLEMENTATION INFORMATION		EXAMPLE OF RECOMMENDED PROJECT
Planning Level Planning/Design/Permitting Cost (\$): 12,500

Project ID#: NC4-002	
Sub-watershed: NC4 North Fork Nancy	
Practice Type: Trash Rack	
<p>Description: Trash rack to capture debris/trash from I-285 runoff. Recommend a floating trash rack downstream of the culvert to capture floatables and debris from the catch basins and associated drainage channels.</p>	
<p>Watershed Goal(s) Supported:</p> <ol style="list-style-type: none"> 1. Meet state water quality standards: Yes 2. Restore stream buffers: No 3. Improve streams to sub-optimal condition: No 4. Wildlife diversity and aesthetics: Yes 	
GENERAL SITE INFORMATION	SITE PHOTOS
Owner: GDOT	
<p>Existing Conditions: Trash and debris from I-285 flow downstream into Murphey Candler Lake.</p>	
WATER QUALITY MODELING DATA	
Contributing Drainage Area (ac): 10	
Contributing Impervious Area (ac): 10	
Primary Hydrologic Soil Group (HSG) in DA: NA	
Annual Total Nitrogen Reduction (lb/yr): 11.77	
Annual Total Phosphorus Reduction (lb/yr): 1.28

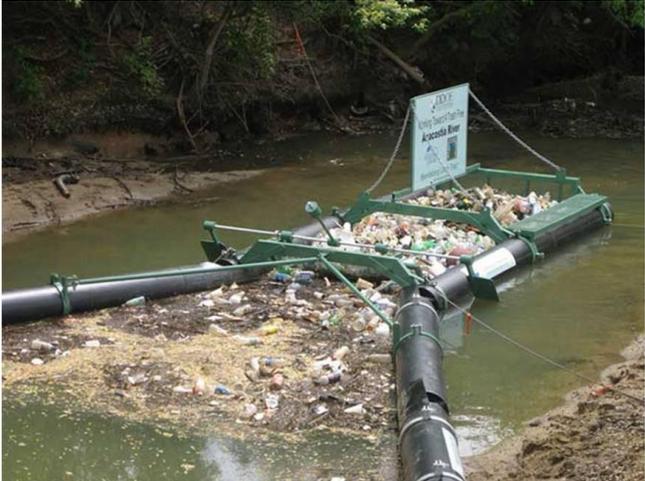
IMPLEMENTATION INFORMATION		EXAMPLE OF RECOMMENDED PROJECT
<p>Planning Level Planning/Design/Permitting Cost (\$): 12,500</p>

Project ID#: NC4-003	
Sub-watershed: NC4 North Fork Nancy	
Practice Type: Trash Rack	
<p>Description: Trash rack to capture debris/trash from I-285 runoff. Recommend a floating trash rack downstream of the culvert to capture floatables and debris from the catch basins and associated drainage channels.</p>	
<p>Watershed Goal(s) Supported:</p> <ol style="list-style-type: none"> 1. Meet state water quality standards: Yes 2. Restore stream buffers: No 3. Improve streams to sub-optimal condition: No 4. Wildlife diversity and aesthetics: Yes 	
GENERAL SITE INFORMATION	SITE PHOTOS
Owner: GDOT	
<p>Existing Conditions: Trash and debris from I-285 flow downstream into Murphey Candler Lake.</p>	
WATER QUALITY MODELING DATA	
Contributing Drainage Area (ac): 10	
Contributing Impervious Area (ac): 10	
Primary Hydrologic Soil Group (HSG) in DA: NA	
Annual Total Nitrogen Reduction (lb/yr): 11.77	
Annual Total Phosphorus Reduction (lb/yr): 1.28

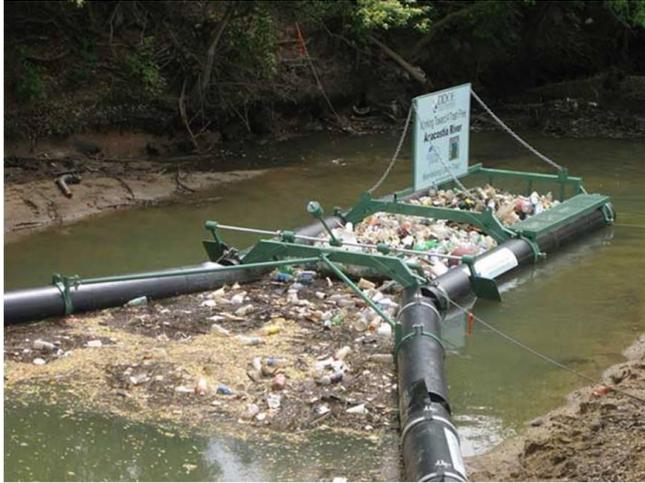
IMPLEMENTATION INFORMATION	EXAMPLE OF RECOMMENDED PROJECT
<p>Planning Level Planning/Design/Permitting Cost (\$): 12,500</p>

Project ID#: NC4-004	
Sub-watershed: NC4 North Fork Nancy	
Practice Type: Trash Rack	
<p>Description: Trash rack to capture debris/trash from I-285 runoff. Recommend a floating trash rack downstream of the culvert to capture floatables and debris from the catch basins and associated drainage channels.</p>	
<p>Watershed Goal(s) Supported:</p> <ol style="list-style-type: none"> 1. Meet state water quality standards: Yes 2. Restore stream buffers: No 3. Improve streams to sub-optimal condition: No 4. Wildlife diversity and aesthetics: Yes 	
GENERAL SITE INFORMATION	SITE PHOTOS
Owner: GDOT	
<p>Existing Conditions: Trash and debris from I-285 flow downstream into Murphey Candler Lake.</p>	
WATER QUALITY MODELING DATA	
Contributing Drainage Area (ac): 10	
Contributing Impervious Area (ac): 10	
Primary Hydrologic Soil Group (HSG) in DA: NA	
Annual Total Nitrogen Reduction (lb/yr): 11.77	
Annual Total Phosphorus Reduction (lb/yr): 1.28

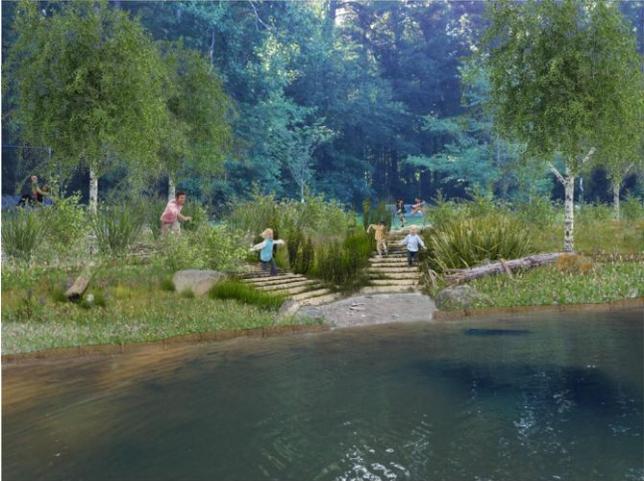
IMPLEMENTATION INFORMATION		EXAMPLE OF RECOMMENDED PROJECT
Planning Level Planning/Design/Permitting Cost (\$): 102,750

Project ID#: NC4-005	
Sub-watershed: NC4 North Fork Nancy	
Practice Type: Shoreline Restoration	
Description: Restore 3,400 linear feet of shoreline around Murphey Candler Lake (shore classified as “poor” or “threatened”).	
Watershed Goal(s) Supported: <ol style="list-style-type: none"> 1. Meet state water quality standards: No 2. Restore stream buffers: Yes 3. Improve streams to sub-optimal condition: No 4. Wildlife diversity and aesthetics: Yes 	
GENERAL SITE INFORMATION	SITE PHOTOS
Owner: City	
Existing Conditions: Existing shoreline conditions are bare or sparsely vegetated and eroding in many areas.	
WATER QUALITY MODELING DATA	
Contributing Drainage Area (ac): -	
Contributing Impervious Area (ac): -	
Primary Hydrologic Soil Group (HSG) in DA: NA	
Annual Total Nitrogen Reduction (lb/yr): 18.82	
Annual Total Phosphorus Reduction (lb/yr): 2.58	
Annual Total Suspended Solids Reduction (lb/yr): 618

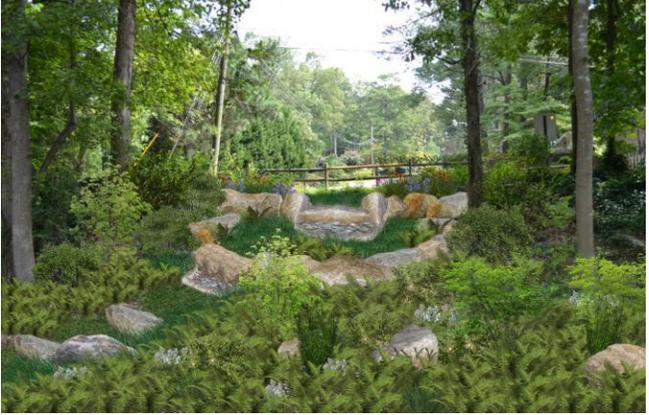
IMPLEMENTATION INFORMATION		EXAMPLE OF RECOMMENDED PROJECT
Planning Level Planning/Design/Permitting Cost (\$): 31,000

Project ID#: NC4-006	
<p>Sub-watershed: NC4 North Fork Nancy</p>	
<p>Practice Type: New BMP</p>	
<p>Description: New bioretention area at the bend in East Nancy Creek Drive in Murphey Candler Park. Recommend three-tiered and tie in adjacent catch basin drainage as well as direct road drainage before draining to the stream.</p>	
<p>Watershed Goal(s) Supported:</p> <ol style="list-style-type: none"> 1. Meet state water quality standards: Yes 2. Restore stream buffers: Yes 3. Improve streams to sub-optimal condition: No 4. Wildlife diversity and aesthetics: Yes 	
GENERAL SITE INFORMATION	SITE PHOTOS
<p>Owner: City</p>	
<p>Existing Conditions: During high flows stormwater bypasses the catch basin and entering the park eroding a path toward the stream.</p>	
WATER QUALITY MODELING DATA	
<p>Contributing Drainage Area (ac): 13.88</p>	
<p>Contributing Impervious Area (ac): 4.13</p>	
<p>Primary Hydrologic Soil Group (HSG) in DA: B</p>

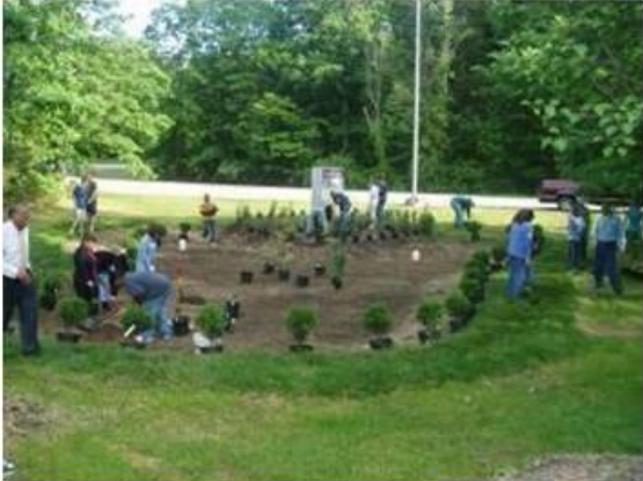
IMPLEMENTATION INFORMATION		EXAMPLE OF RECOMMENDED PROJECT
Planning Level Planning/Design/Permitting Cost (\$): 2,250

Project ID#: NC4-007	
Sub-watershed: NC4 North Fork Nancy	
Practice Type: New BMP	
Description: New bioretention or enhanced swale area in front of Kittredge Magnet School.	
Watershed Goal(s) Supported: <ol style="list-style-type: none"> 1. Meet state water quality standards: Yes 2. Restore stream buffers: Yes 3. Improve streams to sub-optimal condition: Yes 4. Wildlife diversity and aesthetics: Yes 	
GENERAL SITE INFORMATION	SITE PHOTOS
Owner: DeKalb Public Schools	
Existing Conditions: No stormwater controls for existing school. Opportunity to infiltrate rooftop runoff.	
WATER QUALITY MODELING DATA	
Contributing Drainage Area (ac): 0.82	
Contributing Impervious Area (ac): 0.17	
Primary Hydrologic Soil Group (HSG) in DA: NA	
Annual Total Nitrogen Reduction (lb/yr): 4.68	
Annual Total Phosphorus Reduction (lb/yr): 0.63	
Annual Total Suspended Solids Reduction (lb/yr): 150.25

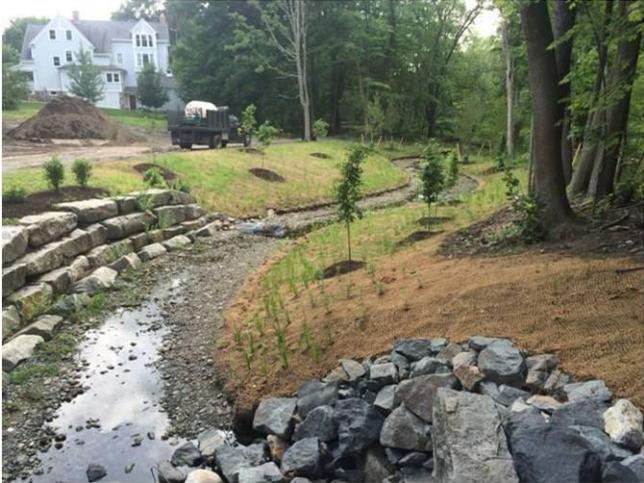
IMPLEMENTATION INFORMATION		EXAMPLE OF RECOMMENDED PROJECT
Planning Level Planning/Design/Permitting Cost (\$): 25,250

Project ID#: NC4-008	
Sub-watershed: NC4 North Fork Nancy	
Practice Type: Stream Restoration	
Description: Restoration of 390 linear feet of eroding drainage channel at Kittredge Magnet School leading into a tributary to Murphey Candler Lake. Associated with NC4-014.	
Watershed Goal(s) Supported: <ol style="list-style-type: none"> 1. Meet state water quality standards: Yes 2. Restore stream buffers: Yes 3. Improve streams to sub-optimal condition: Yes 4. Wildlife diversity and aesthetics: Yes 	
GENERAL SITE INFORMATION	SITE PHOTOS
Owner: DeKalb Public Schools	
Existing Conditions: Severe erosion of drainage channel conveying stormwater from Kittridge Magnet School to an unnamed tributary to Murphey Candler Lake.	
WATER QUALITY MODELING DATA	
Contributing Drainage Area (ac): -	
Contributing Impervious Area (ac): -	
Primary Hydrologic Soil Group (HSG) in DA: NA	
Annual Total Nitrogen Reduction (lb/yr): 3.65

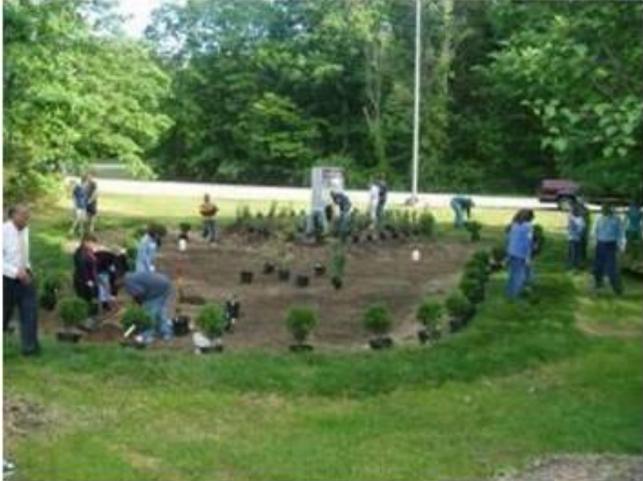
IMPLEMENTATION INFORMATION		EXAMPLE OF RECOMMENDED PROJECT
Planning Level Planning/Design/Permitting Cost (\$): 76,000

Project ID#: NC4-009	
Sub-watershed: NC4 North Fork Nancy	
Practice Type: BMP Retrofit	
<p>Description: Retrofit an existing office stormwater area to retain stormwater and provide water quality treatment and address drainage issue in downstream residential area.</p>	
<p>Watershed Goal(s) Supported:</p> <ol style="list-style-type: none"> 1. Meet state water quality standards: Yes 2. Restore stream buffers: Yes 3. Improve streams to sub-optimal condition: No 4. Wildlife diversity and aesthetics: Yes 	
GENERAL SITE INFORMATION	SITE PHOTOS
Owner: Private Property	
<p>Existing Conditions: Existing stormwater area not designed to retain water. Located upstream of a residential area.</p>	
WATER QUALITY MODELING DATA	
Contributing Drainage Area (ac): 8.39	
Contributing Impervious Area (ac): 3.80	
Primary Hydrologic Soil Group (HSG) in DA: B	
Annual Total Nitrogen Reduction (lb/yr): 49.84	
Annual Total Phosphorus Reduction (lb/yr): 9.32

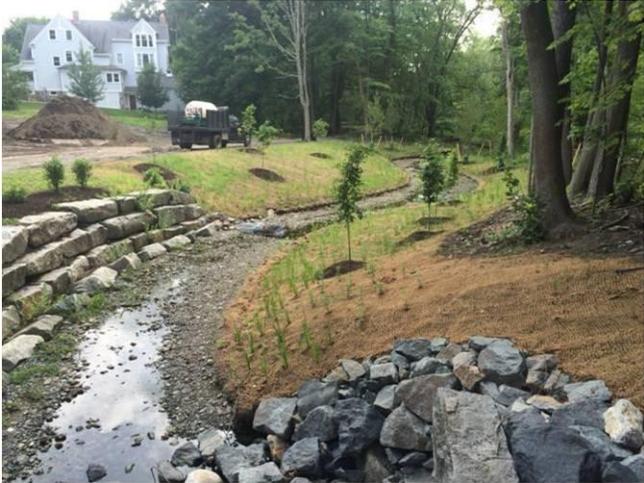
IMPLEMENTATION INFORMATION		EXAMPLE OF RECOMMENDED PROJECT
Planning Level Planning/Design/Permitting Cost (\$): 117,750

Project ID#: NC4-010	
Sub-watershed: NC4 North Fork Nancy	
Practice Type: Stream Restoration	
<p>Description: Restore approximately 3,400 linear feet of North Fork Nancy Creek from I-285 to Murphey Candler Lake that is classified as poor and threatened.</p>	
<p>Watershed Goal(s) Supported:</p> <ol style="list-style-type: none"> 1. Meet state water quality standards: Yes 2. Restore stream buffers: Yes 3. Improve streams to sub-optimal condition: Yes 4. Wildlife diversity and aesthetics: Yes 	
GENERAL SITE INFORMATION	SITE PHOTOS
Owner: City and Private Property	
<p>Existing Conditions: Stream incised with banks reaching 16 feet above normal water level in locations. Stream habitat conditions rated "poor."</p>	
WATER QUALITY MODELING DATA	
Contributing Drainage Area (ac): -	
Contributing Impervious Area (ac): -	
Primary Hydrologic Soil Group (HSG) in DA: NA	
Annual Total Nitrogen Reduction (lb/yr): 17.09

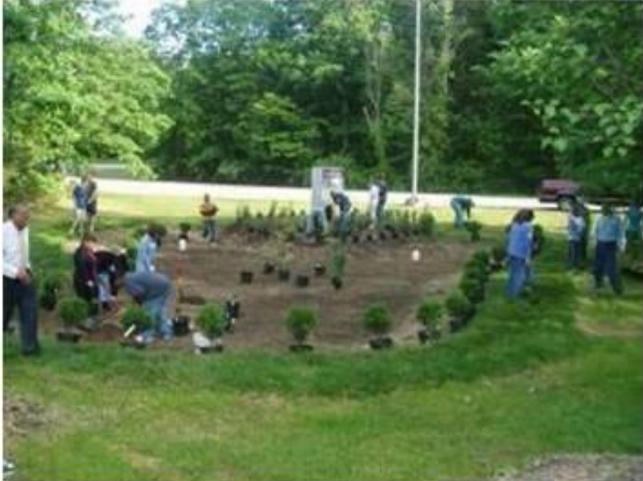
IMPLEMENTATION INFORMATION		EXAMPLE OF RECOMMENDED PROJECT
Planning Level Planning/Design/Permitting Cost (\$): 2,750

Project ID#: NC4-011	
Sub-watershed: NC4 North Fork Nancy	
Practice Type: New BMP	
Description: Provide additional stormwater management with the planned revisions to the parking lot adjacent to Murphey Candler Pool. Options include several bioretention areas, enhanced swales, or street trees.	
Watershed Goal(s) Supported: <ol style="list-style-type: none"> 1. Meet state water quality standards: No 2. Restore stream buffers: Yes 3. Improve streams to sub-optimal condition: No 4. Wildlife diversity and aesthetics: Yes 	
GENERAL SITE INFORMATION	SITE PHOTOS
Owner: City	
Existing Conditions: No stormwater controls for existing pool.	
WATER QUALITY MODELING DATA	
Contributing Drainage Area (ac): 1.44	
Contributing Impervious Area (ac): 0.37	
Primary Hydrologic Soil Group (HSG) in DA: B	
Annual Total Nitrogen Reduction (lb/yr): 10.16	
Annual Total Phosphorus Reduction (lb/yr): 1.36	
Annual Total Suspended Solids Reduction (lb/yr): 326.26

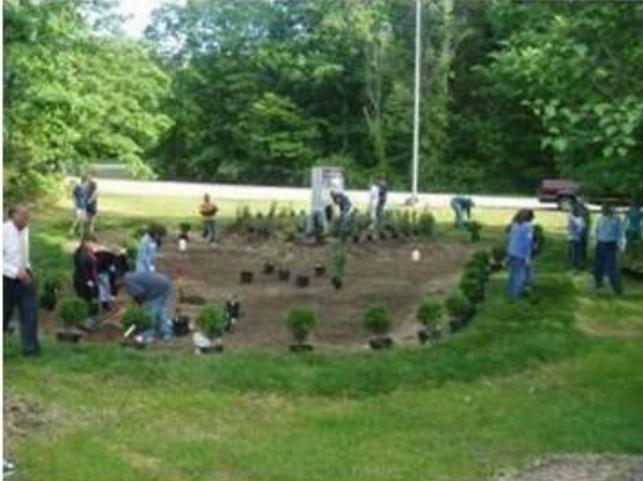
IMPLEMENTATION INFORMATION		EXAMPLE OF RECOMMENDED PROJECT
Planning Level Planning/Design/Permitting Cost (\$): 34,250

Project ID#: NC4-012	
Sub-watershed: NC4 North Fork Nancy	
Practice Type: New BMP	
<p>Description: Address existing drainage issues with the planned sidewalk extension. Add bioswales upstream and downstream of the catch basin.</p>	
<p>Watershed Goal(s) Supported:</p> <ol style="list-style-type: none"> 1. Meet state water quality standards: No 2. Restore stream buffers: Yes 3. Improve streams to sub-optimal condition: No 4. Wildlife diversity and aesthetics: Yes 	
GENERAL SITE INFORMATION	SITE PHOTOS
Owner: City	
Existing Conditions: Erosion downstream of existing catch basin within Murphey Candler Park.	
WATER QUALITY MODELING DATA	
Contributing Drainage Area (ac): 13.79	
Contributing Impervious Area (ac): 4.55	
Primary Hydrologic Soil Group (HSG) in DA: B	
Annual Total Nitrogen Reduction (lb/yr): 123.61	
Annual Total Phosphorus Reduction (lb/yr): 16.55	
Annual Total Suspended Solids Reduction (lb/yr): 3969.97

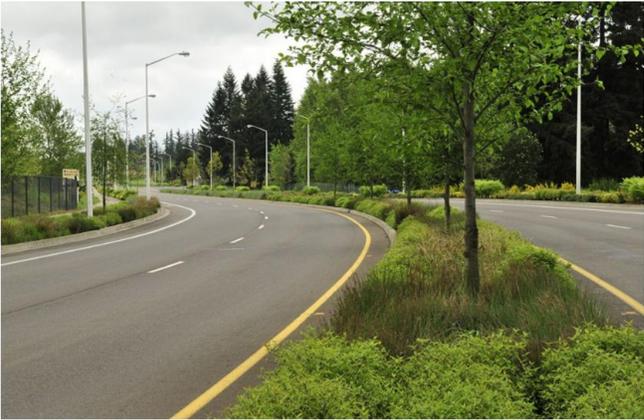
IMPLEMENTATION INFORMATION		EXAMPLE OF RECOMMENDED PROJECT
Planning Level Planning/Design/Permitting Cost (\$): 16,250

Project ID#: NC4-013	
Sub-watershed: NC4 North Fork Nancy	
Practice Type: New BMP	
Description: Provide additional stormwater management with the planned revisions to the parking area along Candler Lake West. Options include several bioretention areas, enhanced swales, or street trees.	
Watershed Goal(s) Supported: <ol style="list-style-type: none"> 1. Meet state water quality standards: No 2. Restore stream buffers: Yes 3. Improve streams to sub-optimal condition: No 4. Wildlife diversity and aesthetics: Yes 	
GENERAL SITE INFORMATION	SITE PHOTOS
Owner: City	
Existing Conditions: Drainage area has few existing stormwater controls.	
WATER QUALITY MODELING DATA	
Contributing Drainage Area (ac): 5.29	
Contributing Impervious Area (ac): 2.16	
Primary Hydrologic Soil Group (HSG) in DA: B	
Annual Total Nitrogen Reduction (lb/yr): 58.67	
Annual Total Phosphorus Reduction (lb/yr): 7.86	
Annual Total Suspended Solids Reduction (lb/yr): 1884.2

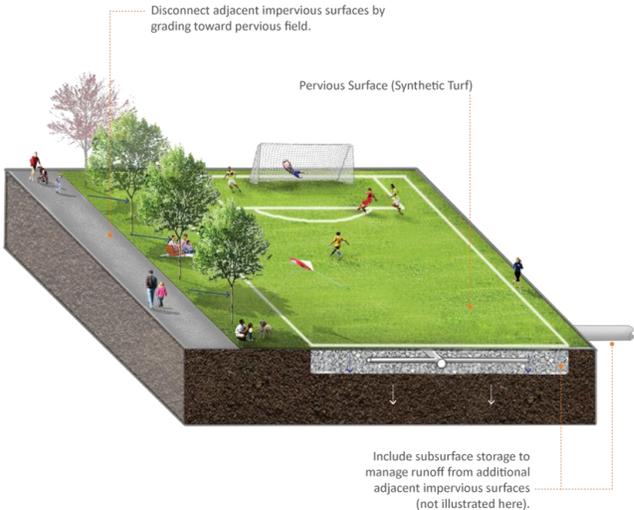
IMPLEMENTATION INFORMATION		EXAMPLE OF RECOMMENDED PROJECT
Planning Level Planning/Design/Permitting Cost (\$): 13,000

Project ID#: NC4-014	
Sub-watershed: NC4 North Fork Nancy	
Practice Type: New BMP	
Description: Provide stormwater management through underground detention associated with upgrades to the existing recreational field and repair to existing drainage at Kittredge Magnet School. Associated with NC4-008.	
Watershed Goal(s) Supported: <ol style="list-style-type: none"> 1. Meet state water quality standards: Yes 2. Restore stream buffers: Yes 3. Improve streams to sub-optimal condition: No 4. Wildlife diversity and aesthetics: Yes 	
GENERAL SITE INFORMATION	SITE PHOTOS
Owner: DeKalb Public Schools	
Existing Conditions: School has no stormwater controls. The inlet at the edge of the recreational field is damaged. The field is muddy after rains.	
WATER QUALITY MODELING DATA	
Contributing Drainage Area (ac): 4.95	
Contributing Impervious Area (ac): 1.04	
Primary Hydrologic Soil Group (HSG) in DA: NA	
Annual Total Nitrogen Reduction (lb/yr): 28.23

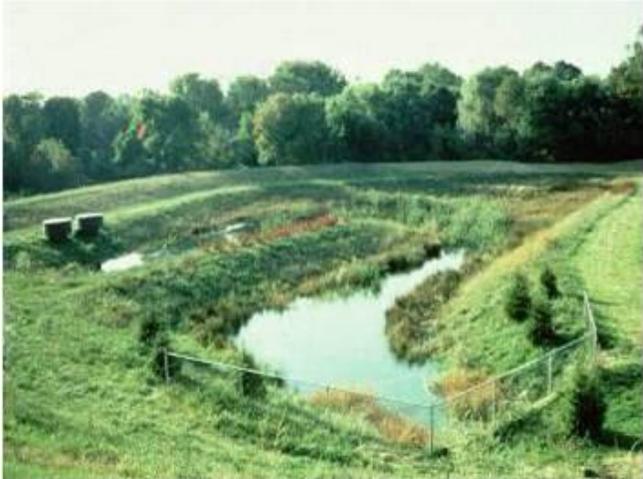
IMPLEMENTATION INFORMATION		EXAMPLE OF RECOMMENDED PROJECT
Planning Level Planning/Design/Permitting Cost (\$): 209,750

Project ID#: NC4-015	
Sub-watershed: NC4 North Fork Nancy	
Practice Type: New BMP	
<p>Description: Create an offline pond area to trap sediment upstream of Murphey Candler Lake, catching drainage from North Fork Nancy Creek. Location to be refined based on planned park survey.</p>	
<p>Watershed Goal(s) Supported:</p> <ol style="list-style-type: none"> 1. Meet state water quality standards: Yes 2. Restore stream buffers: Yes 3. Improve streams to sub-optimal condition: No 4. Wildlife diversity and aesthetics: Yes 	
GENERAL SITE INFORMATION	SITE PHOTOS
Owner: City	
<p>Existing Conditions: Sediment accumulation in Murphey Candler Lake is a concern and expensive to remove. Upstream controls will reduce sediment accumulation.</p>	
WATER QUALITY MODELING DATA	
Contributing Drainage Area (ac): 90.14	
Contributing Impervious Area (ac): 27.98	
Primary Hydrologic Soil Group (HSG) in DA: B	
Annual Total Nitrogen Reduction (lb/yr): 42.83

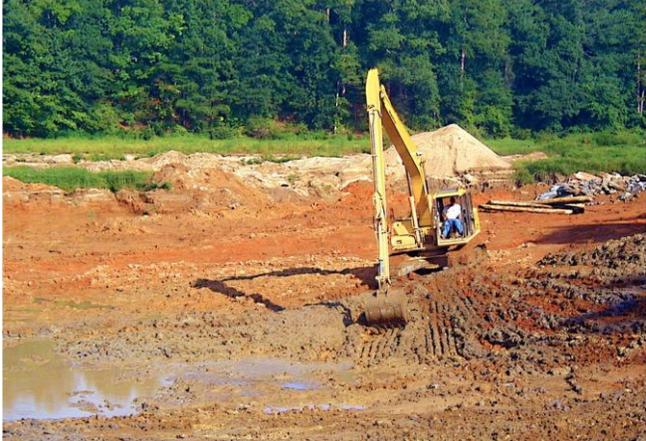
IMPLEMENTATION INFORMATION		EXAMPLE OF RECOMMENDED PROJECT
Planning Level Planning/Design/Permitting Cost (\$):

Project ID#: NC4-016	
Sub-watershed: NC4 North Fork Nancy	
Practice Type: Sediment Removal	
Description: Maintenance dredging of accumulated sediment in the northern and eastern coves in Murphey Candler Lake.	
Watershed Goal(s) Supported: <ol style="list-style-type: none"> 1. Meet state water quality standards: No 2. Restore stream buffers: No 3. Improve streams to sub-optimal condition: No 4. Wildlife diversity and aesthetics: Yes 	
GENERAL SITE INFORMATION	SITE PHOTOS
Owner: City	
Existing Conditions: Sediment accumulation in Murphey Candler Lake is visible in the upper coves and eastern cove.	
WATER QUALITY MODELING DATA	
Contributing Drainage Area (ac): -	
Contributing Impervious Area (ac): -	
Primary Hydrologic Soil Group (HSG) in DA: NA	
Annual Total Nitrogen Reduction (lb/yr): -	
Annual Total Phosphorus Reduction (lb/yr): -	
Annual Total Suspended Solids Reduction (lb/yr): -

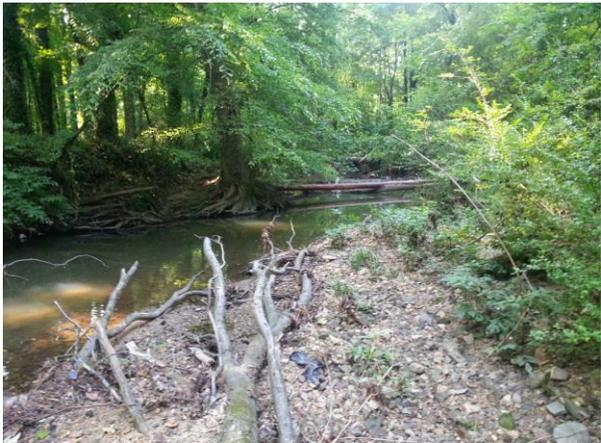
Practice Type: Stream Restoration	
<p>Description: Restore stream and add grade control structures to mitigate velocity and protect infrastructure adjacent to the stream. Protect wide buffers, where exist. Partner with MARTA and private property owners.</p>	
<p>Watershed Goal(s) Supported:</p> <ol style="list-style-type: none"> 1. Meet state water quality standards: Yes 2. Restore stream buffers: Yes 3. Improve streams to sub-optimal condition: Yes 4. Wildlife diversity and aesthetics: Yes 	
GENERAL SITE INFORMATION	SITE PHOTOS
Owner: City, Public, and Private Property

<p>Existing Conditions: Stream habitat conditions rated "sub-marginal". No riffles. Sedimentation dominated conditions in this section. Some bank erosion.</p>	
WATER QUALITY MODELING DATA	
Contributing Drainage Area (ac): -	
Contributing Impervious Area (ac): -	
Primary Hydrologic Soil Group (HSG) in DA: NA

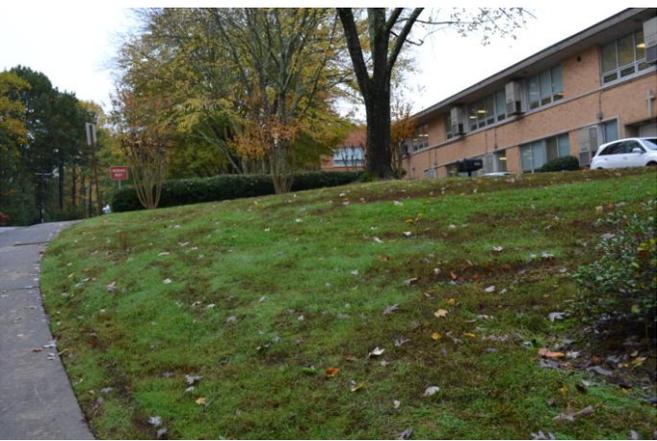
Practice Type: New BMP	
Description: Opportunities to integrate one or more bioretention facilities at the Our Lady of the Assumption Catholic Church. Integrate project into school science curriculum.	
Watershed Goal(s) Supported: <ol style="list-style-type: none"> 1. Meet state water quality standards: Yes 2. Restore stream buffers: Yes 3. Improve streams to sub-optimal condition: No 4. Wildlife diversity and aesthetics: Yes 	
GENERAL SITE INFORMATION	SITE PHOTOS
Owner: Private Property

Existing Conditions: Existing school with no stormwater management. Opportunity to infiltrate stormwater runoff.	
WATER QUALITY MODELING DATA	
Contributing Drainage Area (ac): 7.31	
Contributing Impervious Area (ac): 1.75	
Primary Hydrologic Soil Group (HSG) in DA: NA	
Annual Total Nitrogen Reduction (lb/yr): 53.87	
Annual Total Phosphorus Reduction (lb/yr): 7.21

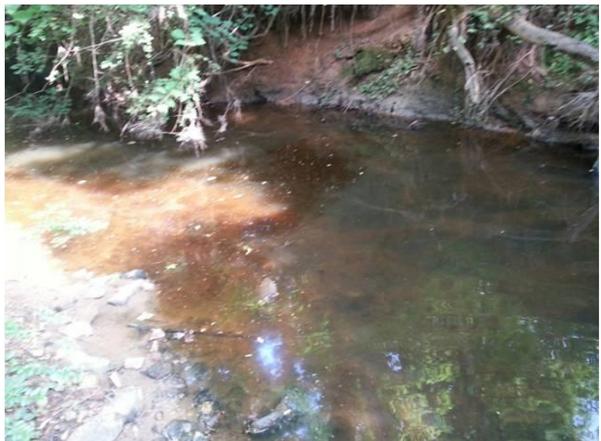
Practice Type: Stream Restoration	
<p>Description: Restore stream and protect utilities upstream of Little Silver Lake. Coordinate with the ongoing Ashford Dunwoody Road corridor study and any recommended projects.</p>	
<p>Watershed Goal(s) Supported:</p> <ol style="list-style-type: none"> 1. Meet state water quality standards: Yes 2. Restore stream buffers: Yes 3. Improve streams to sub-optimal condition: Yes 4. Wildlife diversity and aesthetics: Yes 	
GENERAL SITE INFORMATION	SITE PHOTOS
Owner: Private Property	
<p>Existing Conditions: Stream habitat conditions rated "sub-marginal". Erosion and sedimentation in the segment upstream of Little Silver Lake.</p>	
WATER QUALITY MODELING DATA

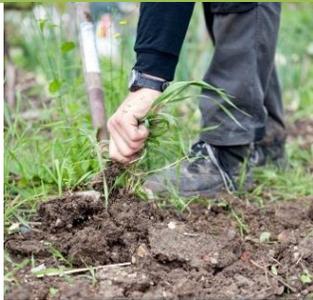
<p>Uprooting Application: vines, shrubs, saplings <3 inches in diameter</p> <p>A small digging fork may be used to extract the root system. Shovels are not recommended as they may cut the root system, leaving it in the ground to re-grow. Tools for larger woody plants include a Weed Wrench™, Root Jack, or Root Talon. These tools are designed to remove the plant and entire root system. Pulling works on many invasive species and during all seasons. Uprooting is highly effective when the entire plant is removed. Pulling is easiest after a rain event</p>

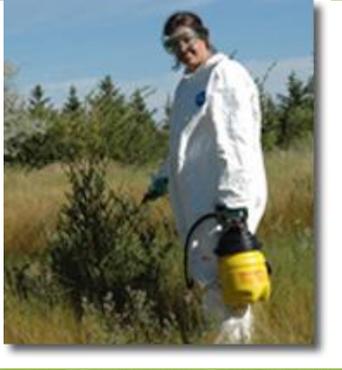
Technique	Example
<p>Foliar Chemical Applications Applications: herbaceous plants, shrubs</p> <p>Foliar chemical applications are appropriate for small scale or isolated invasive species problems. Typically the herbicide is applied from a backpack or handheld spray bottle. All herbicides should be mixed and applied following the manufacturer’s directions. Chemical applications should not be done on windy days as the spray can drift from invasive species and impact nearby native plants. The spray should thoroughly wet the leaves and be applied when rain is not in the forecast for the next 24 to 48 hours. Spraying is most effective when the plants are actively growing; for example when they are flowering or beginning to form fruit.</p>

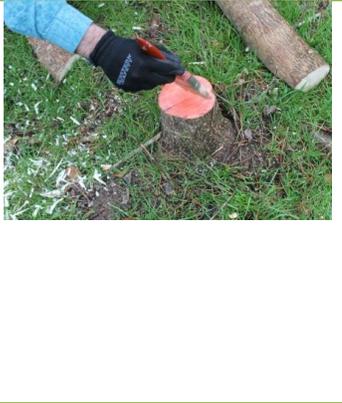
<p>Cut Stem or Cut and Paint Applications:</p> <p>For plants that are too big to pull, either the cut stem or cut and paint techniques are effective. The top of the plant is cut and then an herbicide is applied to the cut stem. Higher concentrations of herbicide are needed for this than recommended for foliar applications; following manufacturer’s recommendations for concentration and application. This technique is most effective in late summer and autumn. Stumps should be cut close to the ground and herbicide applied shortly after cutting with either a sponge, paint brush, or spray bottle. Delaying the herbicide application can limit effectiveness. Dye may be added to the herbicide solution to make tracking plants that have been treated easier to spot.</p>

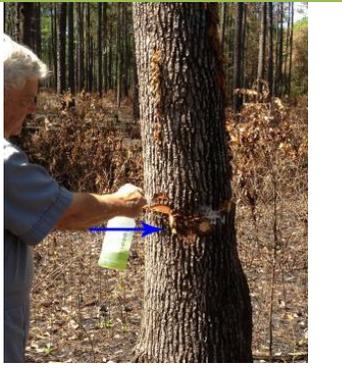
<p>Girdle or “Hack and Squirt” Applications:</p> <p>For some larger invasive trees and shrubs, these techniques allow herbicide to be more effectively applied without topping the tree to a stump. To girdle a tree, the bark and vascular tissue under the bark are removed and a ring cut near the base of the plant around the entire circumference. An herbicide solution is immediately applied to the girdle following manufacturers’ instructions. The hack and squirt method involves making uniform cuts in the trunk of a tree or shrub, that create little “cups”. The cups are immediately filled with an herbicide solution following manufacturers’ instructions.</p>

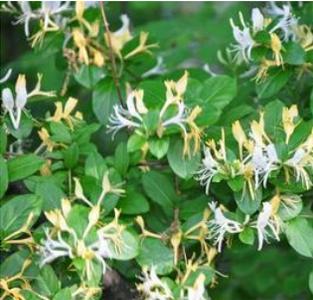
<p>Japanese honeysuckle (<i>Lonicera japonica</i>)</p>

<p>General Information Japanese honeysuckle is a woody perennial, evergreen to semi-evergreen vine that can be found either trailing or climbing to over 80 feet long. Japanese honeysuckle can girdle small saplings by twining around them, and can form dense mats in the canopies of trees, shading everything below.</p> <p>Foliage Leaves are opposite, pubescent, oval and 1-2.5 in. (2.5-6.4 cm) long. Margins are usually entire but young leaves may be lobed or toothed.</p> <p>Flowers Flowering occurs from April to July, when showy, fragrant, tubular, whitish-pink flowers develop in the axils of the leaves. The flowers turn cream-yellow as they age.</p> <p>Fruit The small shiny globular fruits turn from green to black as they ripen. Each fruit contains 2-3 small brown to black ovate seeds.</p>	<p>Because Japanese honeysuckle is so difficult to control when it is established, control programs often kill 100-percent of the plants in the surrounding area. Removing above ground stems by cutting or pulling will temporarily weaken but not kill the plant. Japanese honeysuckle will resprout from subterranean buds and roots as well as from cut branchlets.</p>

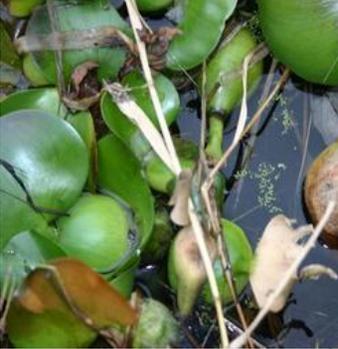
<p>Common water hyacinth (<i>Eichhornia crassipes</i>)</p>

<p>General Information Common water hyacinth is a free floating aquatic plant that invades aquatic areas. Plants can grow to 3 feet tall. Water hyacinth can quickly form dense floating mats of vegetation. Populations can double in size in two weeks. These dense mats restrict light to the underwater environment, reduce the light availability for submersed plants and aquatic invertebrates, and deplete the oxygen levels.</p> <p>Foliage The leaves are oval to elliptical, thick, up to 6 in. (15 cm) wide and waxy with spongy petioles. Leaves curve inward at the edges.</p> <p>Flowers The very showy blue-purple flowers are born on upright spikes. Each flower has six petals with the uppermost having a yellow patch.</p> <p>Fruit This plant reproduces chiefly by vegetative means.</p>	<p>A small infestation can be controlled by hand pulling but typically herbicides are needed. Plans to use herbicides must be carefully evaluated to avoid unintended damage to other aquatic organisms.</p> <p>Certain fish species can also reduce populations. Care must be taken to protect native fish species. Chinese grass carp that are sterile are sometimes stocked to avoid outcompeting native fish species.</p>

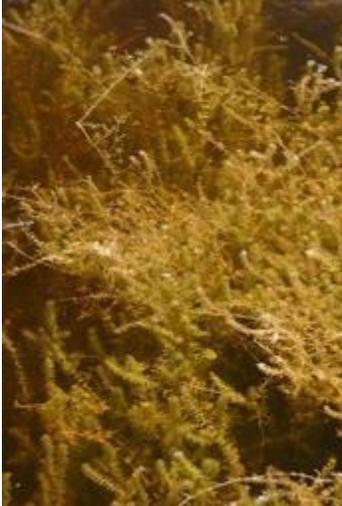
<p>Hydrilla (<i>Hydrilla verticillata</i>)</p>	<p>General Information Hydrilla is a submersed, rooted aquatic plant that can grow in water up to depths of 20 feet. Plants can survive in depths up to 40 feet in non-turbid water. Hydrilla forms dense mats at the surface of the water. The dense mats can restrict native vegetation, irrigation practices, recreation, hydroelectric production, and water flow. It can invade most slow-moving or still water systems.</p> <p>Foliage Leaves are whorled in bunches of 3-8, but most often with whorls of 5. The</p>	<p>Mechanical controls including harvesting is effective for small initial populations. All parts of the plant should be removed and properly disposed. Special harvesters are available for larger infestations.</p> <p>Seasonal drawdowns can also be effective in controlling hydrilla , especially when the drawdown occurs in the fall when tubers are developing.</p>

<p>midribs of the leaves are reddish in color with the undersides having small, raised teeth. Leaves are 0.2-0.8 inches long, less than 0.1 in. (2 mm) wide and have serrated margins.</p> <p>Flowers Only the female flowers of this dioecious plant have been found in the United States, which means no viable seed are produced.</p> <p>Fruit Turions (stem tubers) are bud-like structures which can drop off the plant and successfully survive freezing or drought. Tubers from the rhizomes are another way these plants reproduce and increase their invasive potential.</p>	<p>If the infestation is larger, herbicidal or biological controls may be evaluated. The impact on waterbodies should be carefully measured against the benefits associated with removal.</p>
